The Mystery of the Missing Bolts: New York City's Stricken Indian Point Nuclear Plant

A collaboration between Friends of the Earth and Fairewinds Associates, Inc

May 24, 2016

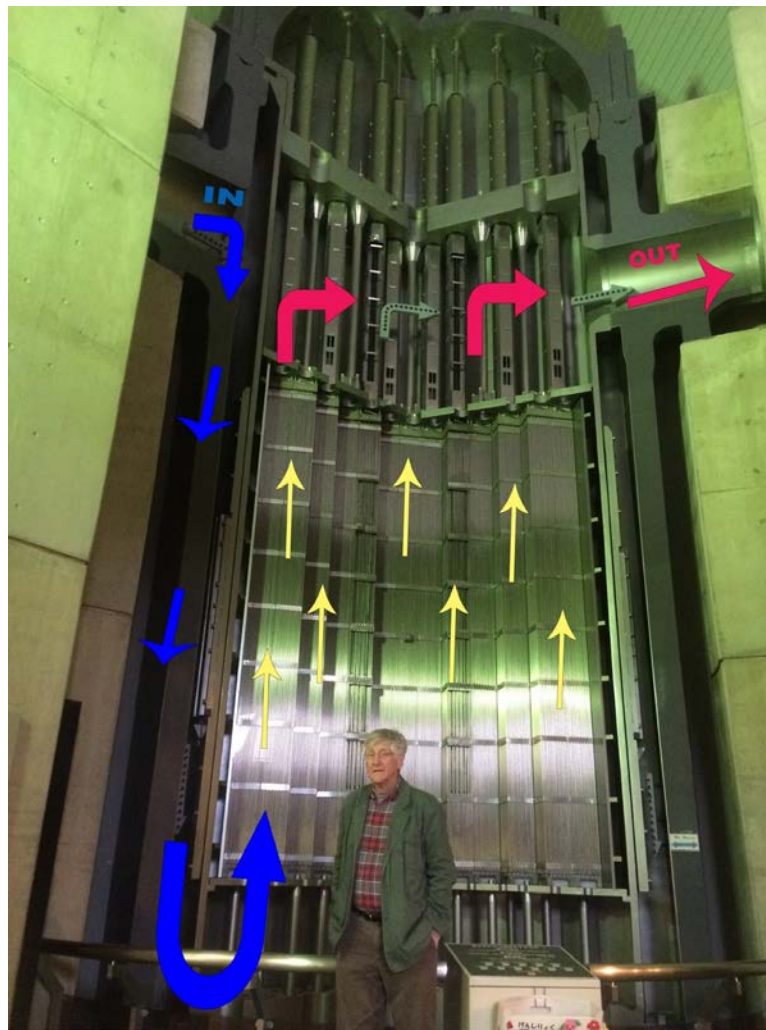
Figure 1 shows Fairewinds Associates' Chief Engineer at a full-scale mockup of a Westinghouse nuclear reactor similar to Indian Point Unit 2. The reactor's emergency cooling water, depicted in blue, enters at the upper-left corner. When the baffle bolts and other reactor internals are functioning properly, the water descends along the outside of the reactor's "core barrel" to the base of the reactor. It then moves uniformly upward through the nuclear core, keeping the core temperature in the safety zone, before exiting the reactor at top right.

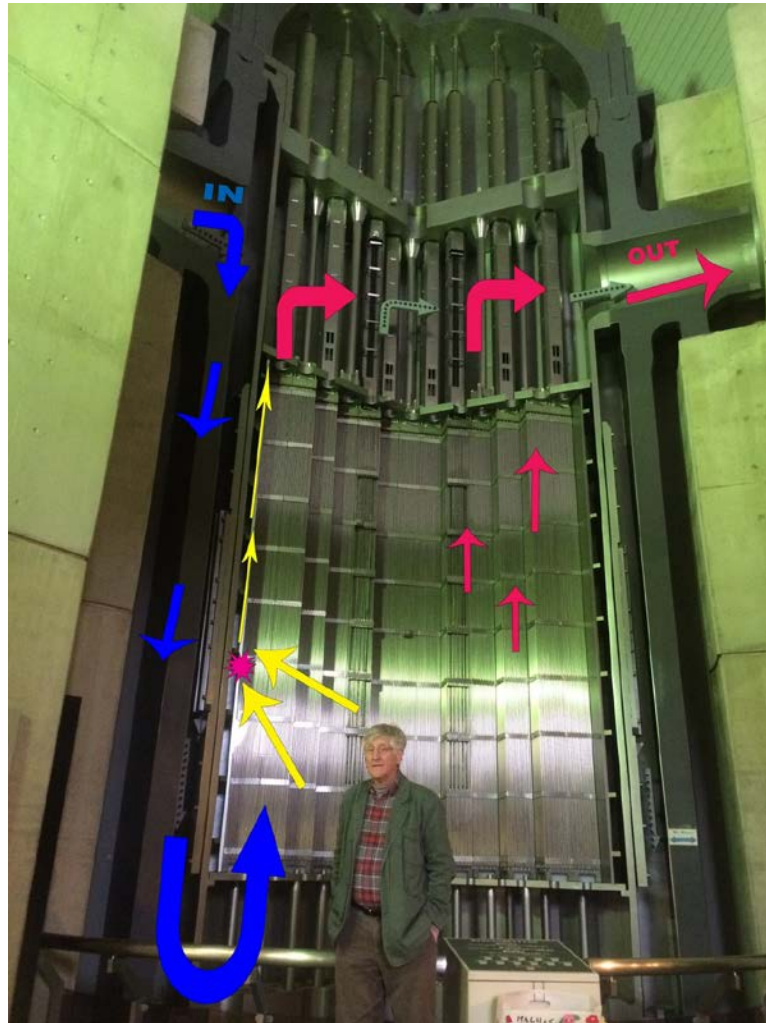
Figure 2 illustrates how missing or damaged baffle bolts can cause the reactor to overheat. If the bolts fail, the plates will open, allowing the cooling water to deviate from its normally tightly constrained path through the reactor, risking overheating of the reactor core and an uncontrollable nuclear reaction and meltdown.
